Holding Pond Annual Inspection Report Shiras Steam Plant

Marquette, Michigan

January 8, 2020
GEI Project No. 1903625

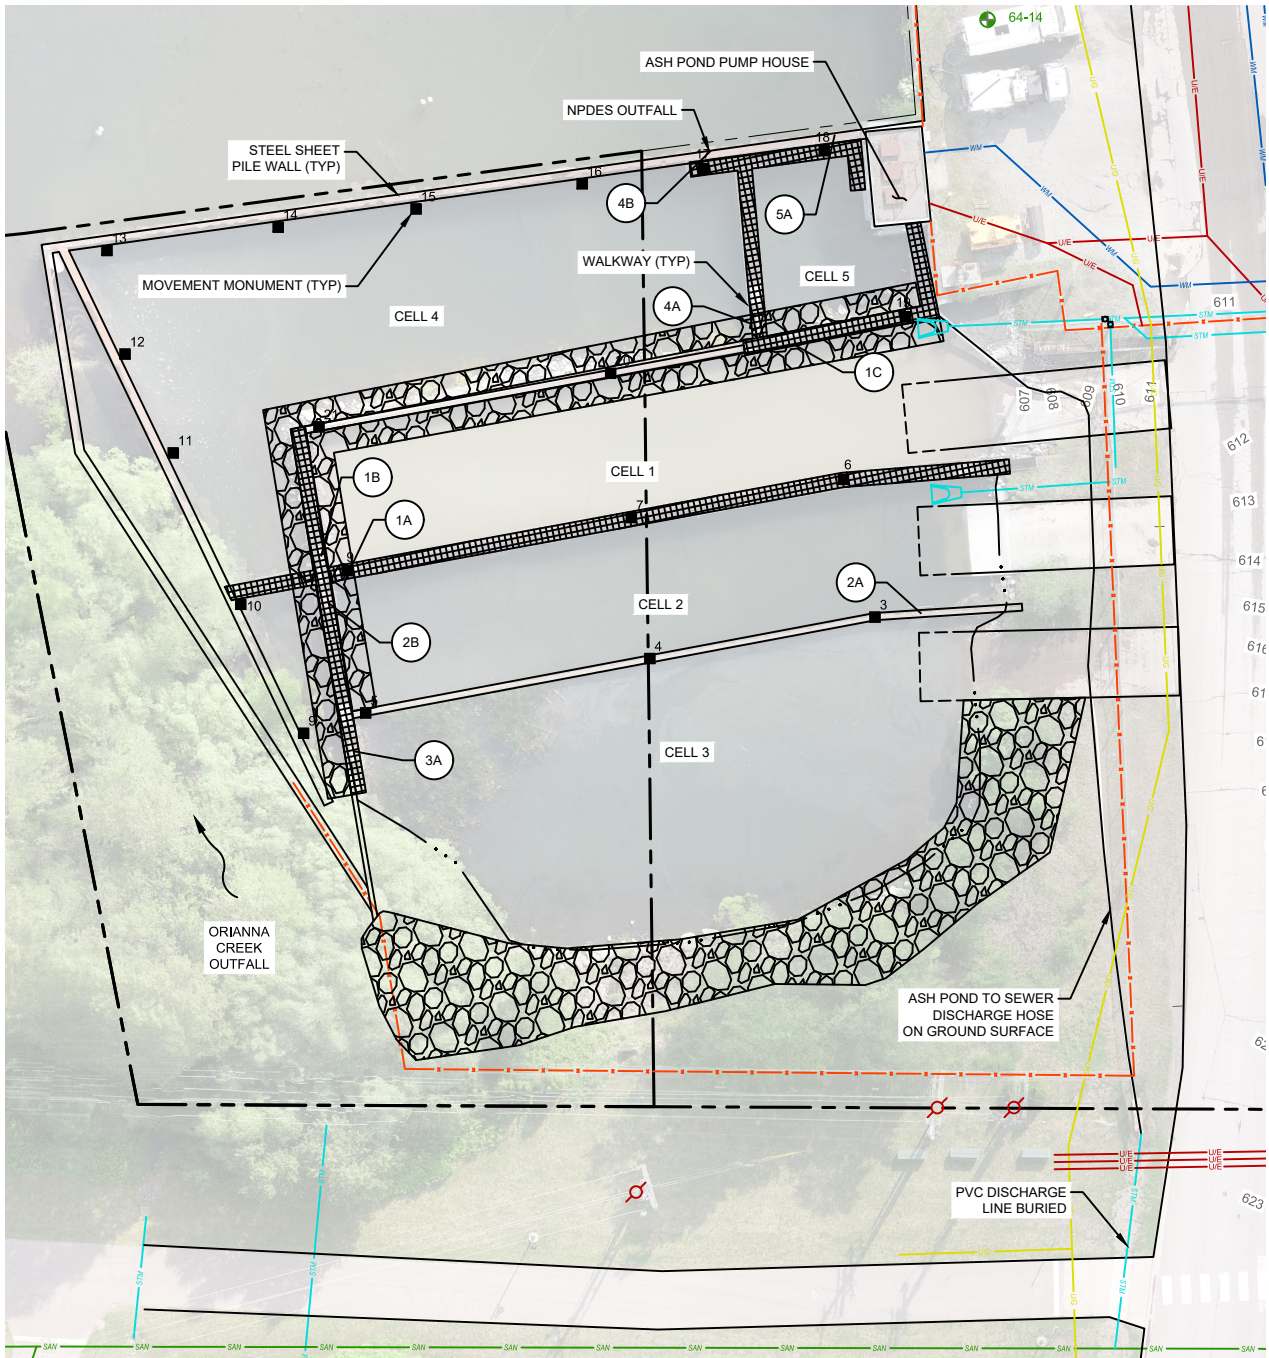
The overall holding pond configuration is shown in plan view on Drawing 1 of Appendix A. Photo 1 of Appendix C shows Cells 3, 2, and 1 from the South. Photo 2 of Appendix C shows Cells 1, 4, and 5 from the South.

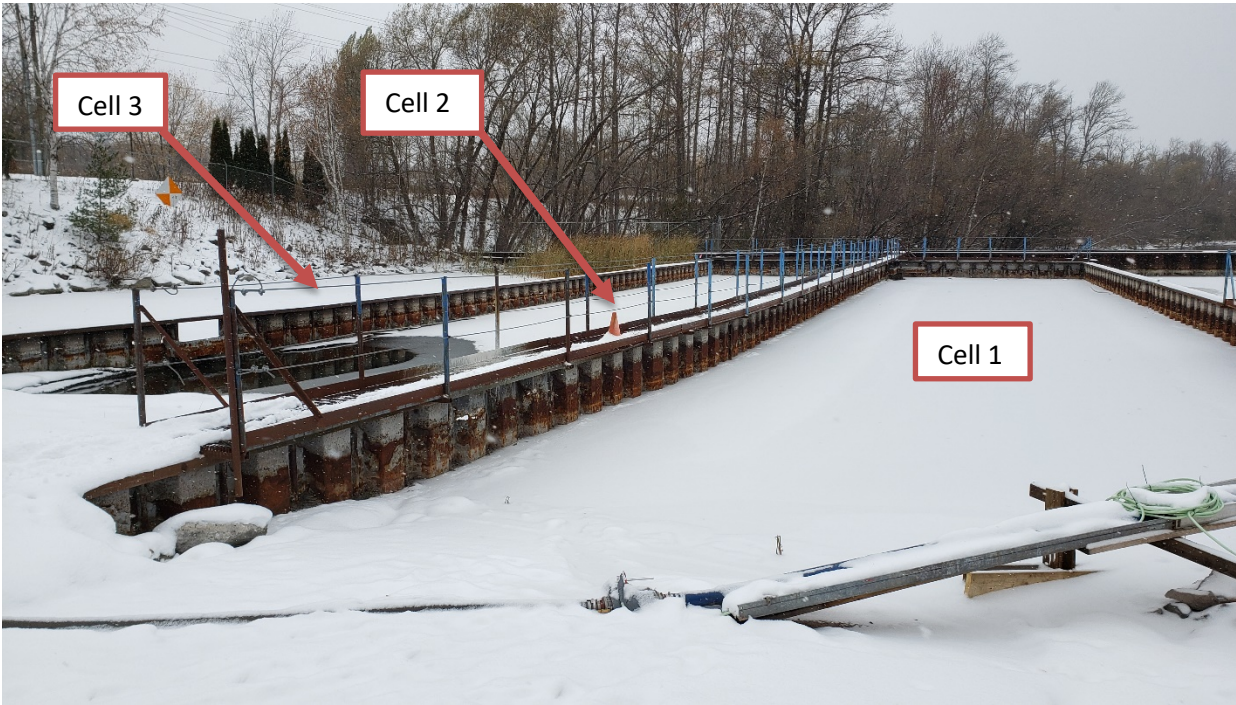
Photo No. 1 – Cells 3, 2, and 1

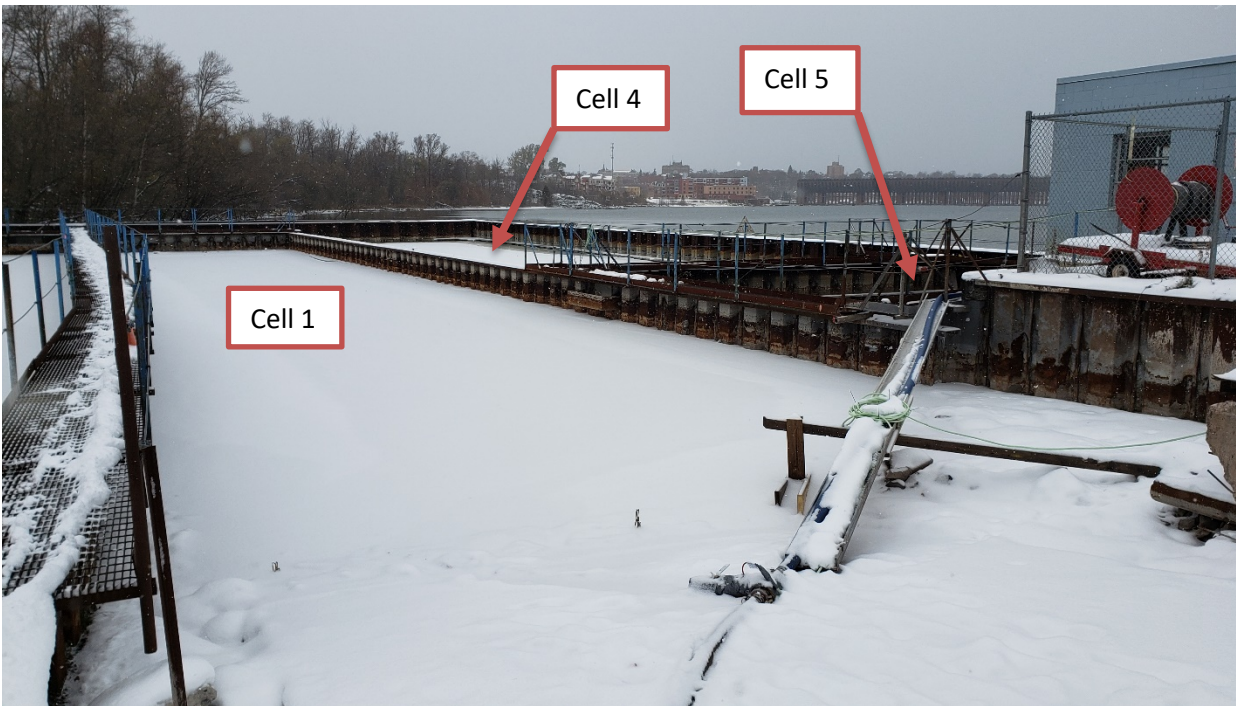
Photo No. 2 – Cells 1, 4, and 5

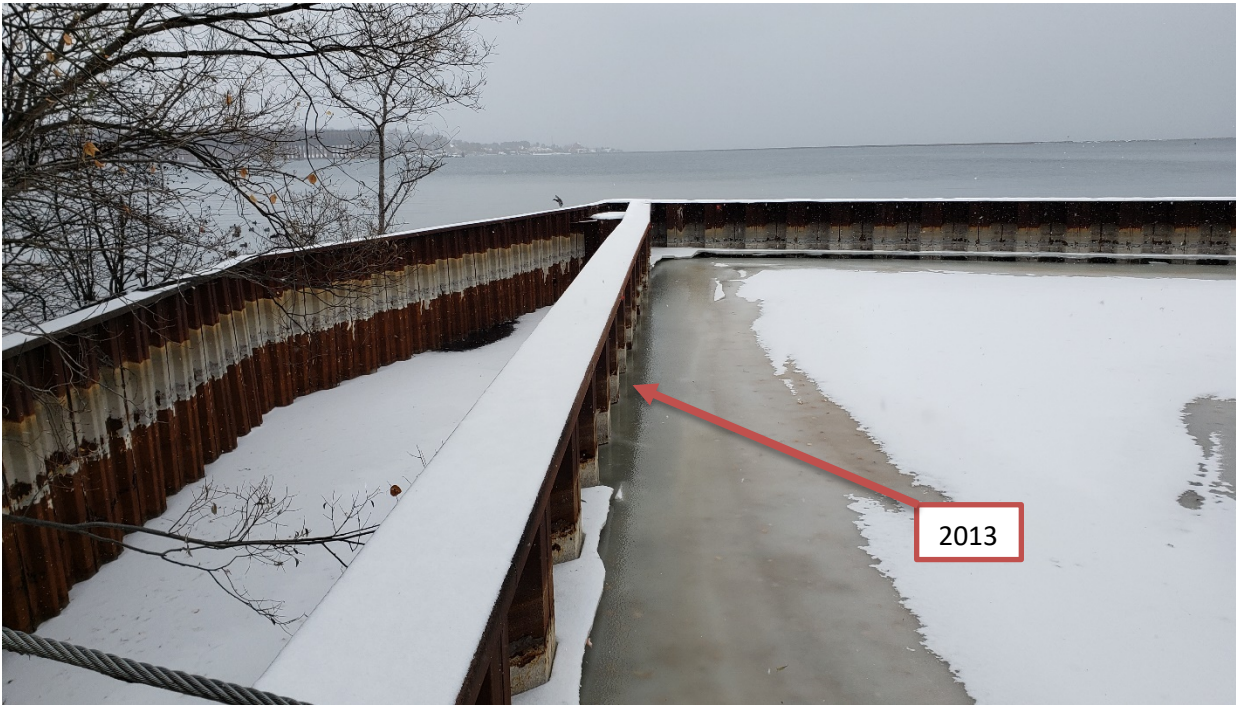
In 2013, an additional north sheet pile wall was installed slightly south of the original north boundary wall because the original wall was found to be in poor condition. The original north wall remains in place but no longer provides containment for the CCR surface water impoundment. The 2013 sheet pile wall provides containment at the north boundary as shown in Photo 3 of Appendix C.

Photo No. 3 – North Sheet Pile Wall

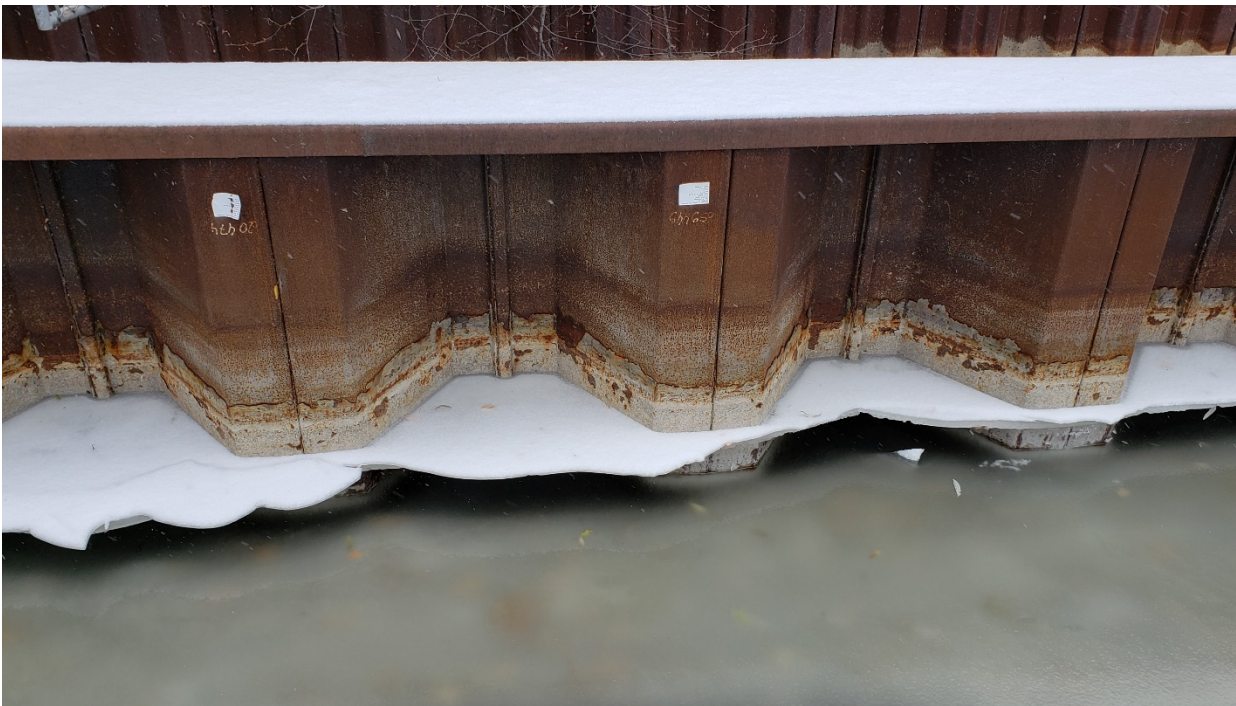
A visual structural evaluation of the holding pond sheet pile walls was performed by GEI on November 13, 2019. The sheet pile used for the exterior walls are hot rolled Z-shaped sections with 12-inch depth and 3/8-inch nominal thickness, similar to a PZ-27 sheet pile (AECOM, 2018). As shown in Photo 4 of Appendix C, the north wall installed in 2013 is in good condition and provides adequate containment. The east wall is also in good condition overall, as shown in Photo 5.

Photo No. 4 – North Sheet Pile Wall Condition

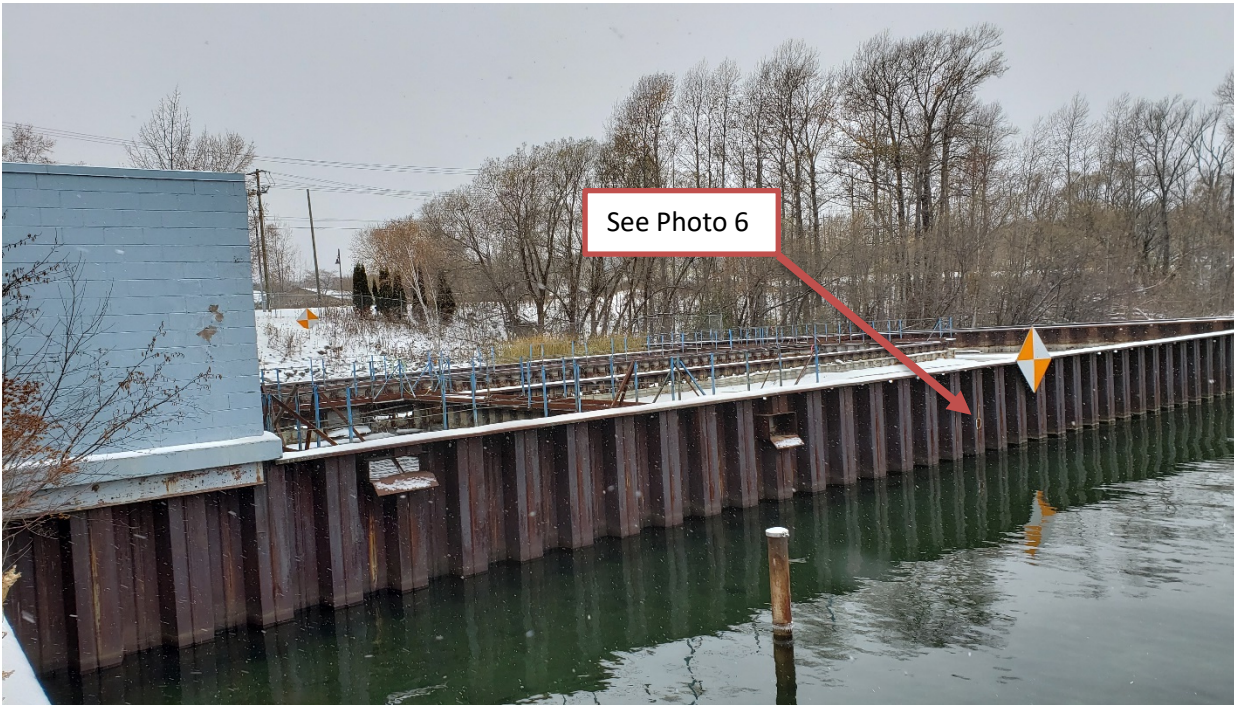
Photo No. 5 – East Sheet Pile Wall Condition

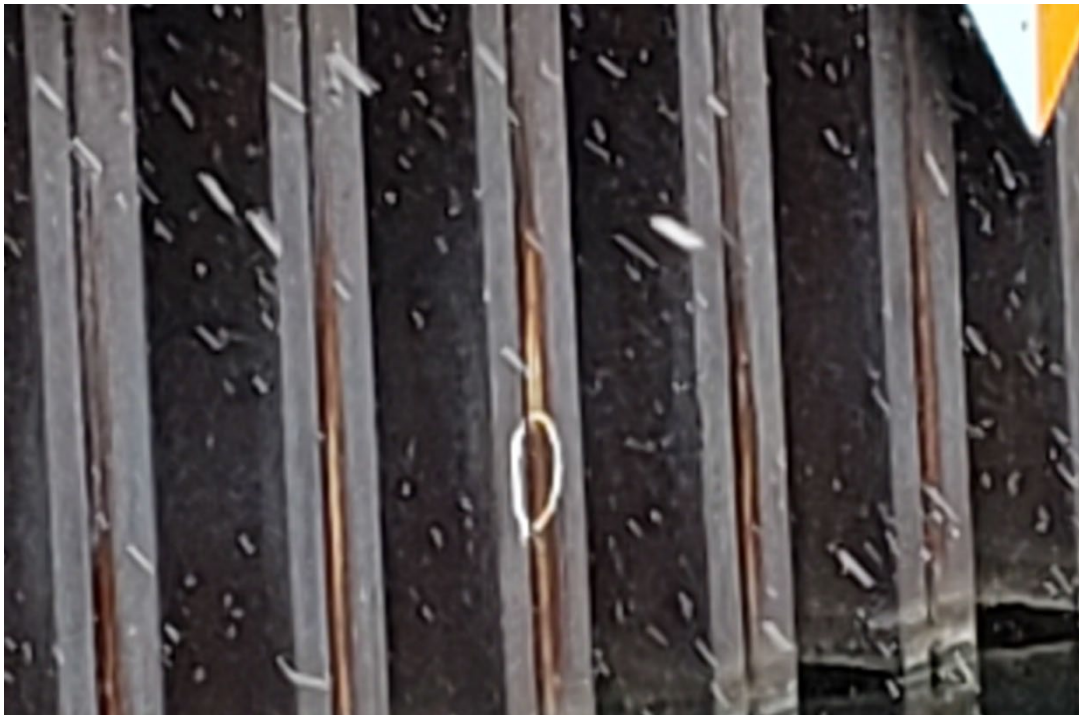
In 2018, AECOM marked a spot of localized corrosion to monitor at a joint between two sheets on the east wall. As shown in Photo 6, the white paint that AECOM used to circle the location is still visible and there appears to be no changes in the sheet pile condition over the past year. The exterior sheets provide adequate containment for the CCR surface water impoundment and no seepage to Lake Superior was evident during GEI's inspection. Although a movement monitoring survey was not conducted as part of this inspection, there appeared to be no indication of movement or distress in the exterior walls. The east wall alignment is shown in Photo 7.

Photo No. 6 – East Wall Joint to Monitor

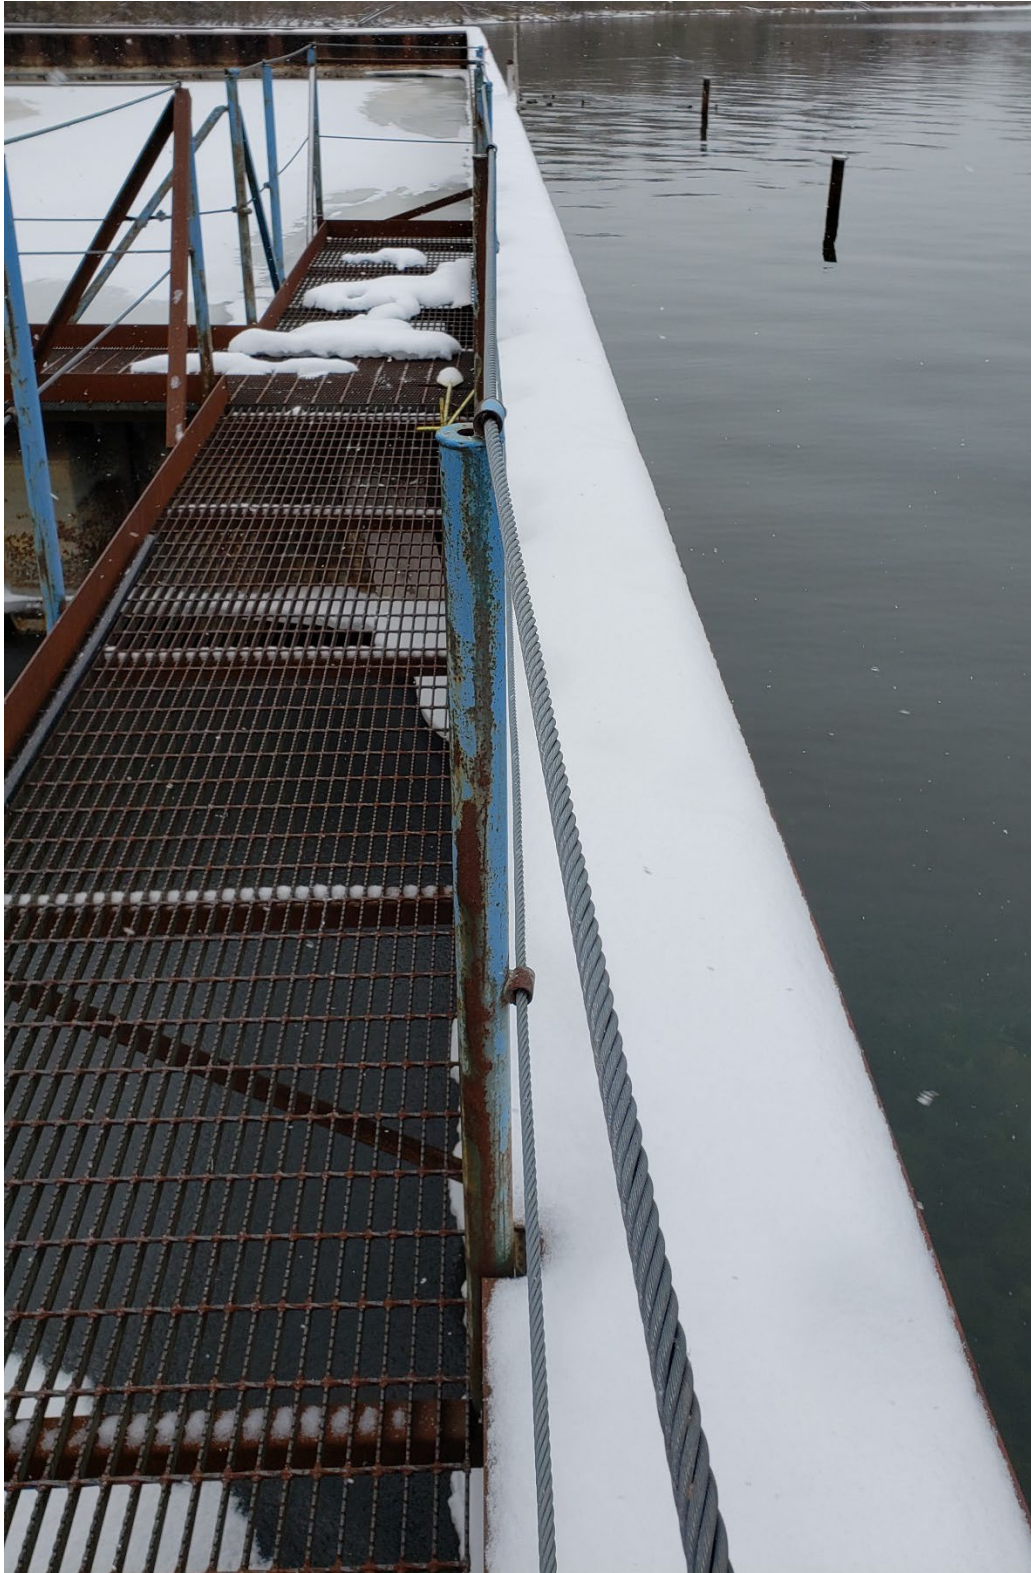
Photo No. 7 – East Wall Alignment

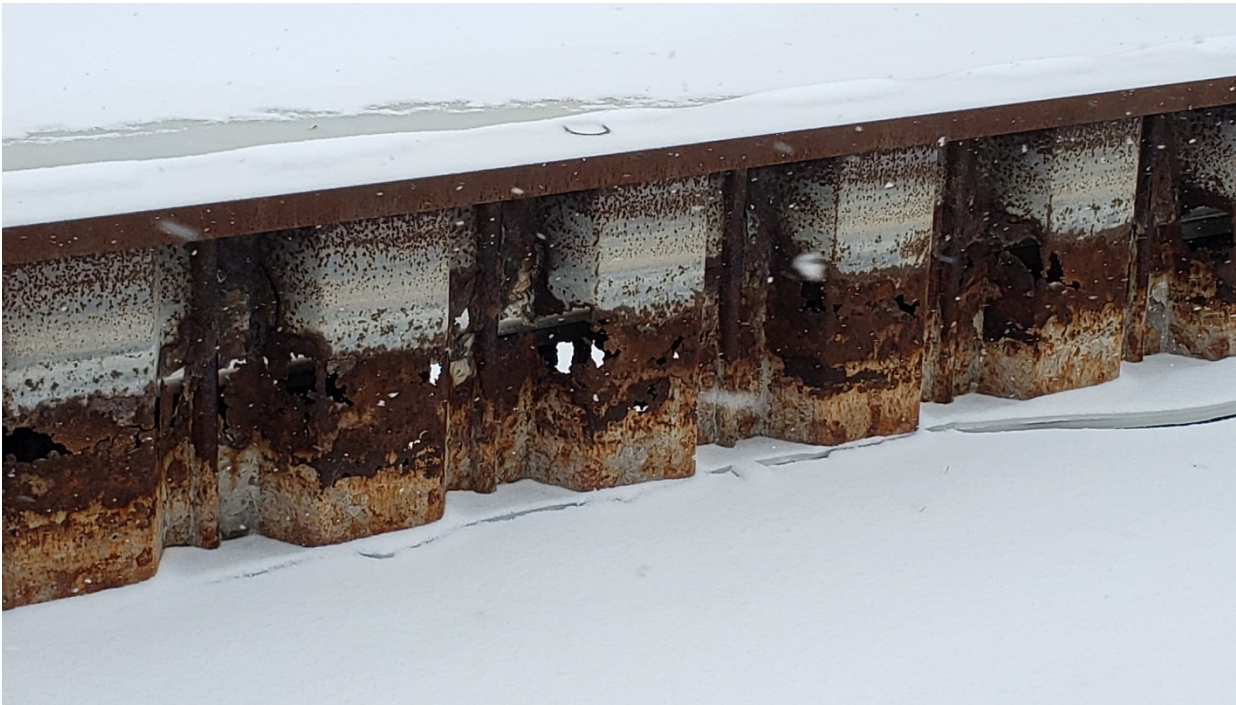
The interior sheet pile walls are constructed of a different type of sheet pile than the exterior walls. The interior walls are in very poor condition and some locations have 100% section loss (Photo 8). Many of the interior walls have had an adjacent sheet pile wall installed to provide a replacement barrier between the cells (Photo 9). The quality of the interior walls does not impact the ability of the exterior walls to contain CCR ash from Lake Superior. No indication of interior wall movement was visually apparent during the inspection.

Photo No. 8 – Interior Wall Condition

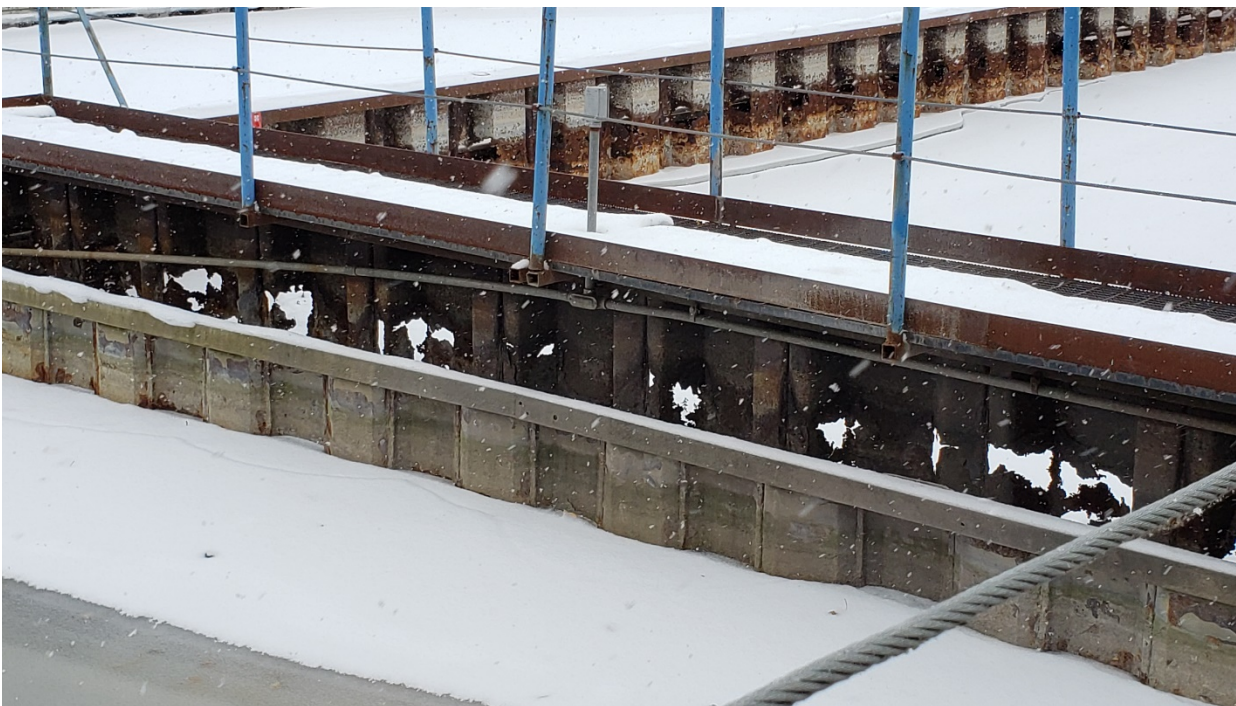
Photo No. 9 – Adjacent Interior Walls
